*Our File Reference*  
A16O0137-D1-A1

06 December 2016

**Subject: AVIATION SAFETY ADVISORY A16O0137-D1-A1**  
**Zenair Zodiac CH-601A – Risk of structural failure of the horizontal stabilizer**

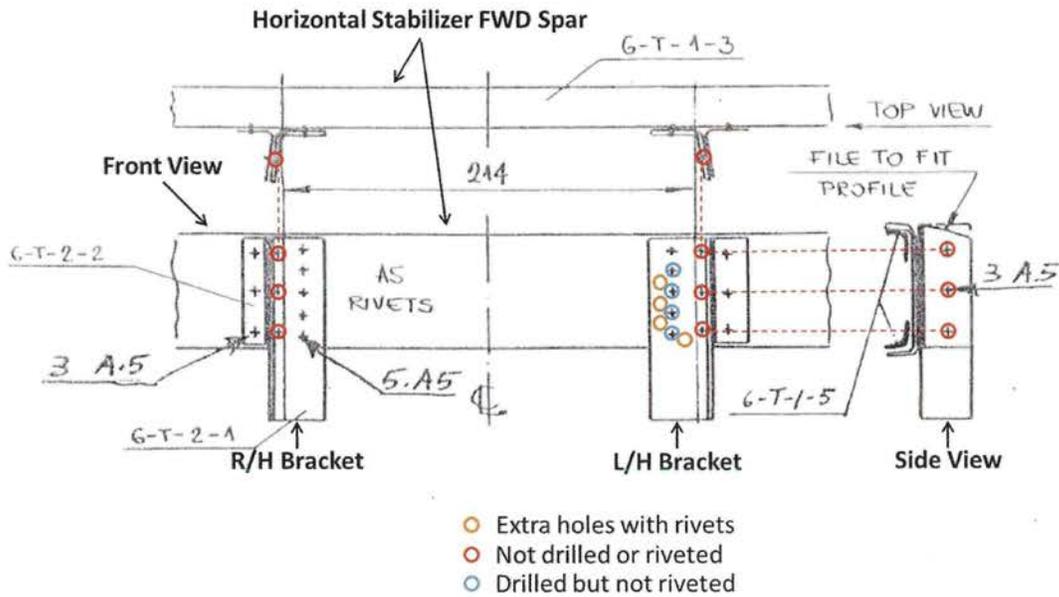
As per the drawing (Figure 1), the horizontal stabilizer forward structural attachment is designed to be constructed by riveting two aluminium angles (attachment bracket 6-T-2-1 and attachment doubler 6-T-2-2) with three rivets back-to-back and connecting the attachment bracket to the front surface of the forward spar (6-T-1-3) with five rivets.

In the actual installation, the three rivets connecting each attachment bracket to the associated attachment doubler were missing and the required holes were not drilled. Four additional holes were drilled through the left attachment bracket and continued through the forward spar. Rivets were installed in all of these additional holes; however, they were only installed in one of the five holes specified in the drawing.

**Figure 1.** Horizontal stabilizer forward structural attachment—aircraft drawing. (source: Zenair, with digital annotations by the TSB)

Structural integrity of the horizontal stabilizer forward attachment point was compromised on both sides because of the missing rivets, and the strength of the forward spar itself was reduced because of the extra holes.
