- January 2022 -

## Making a Splash... Hopefully.

There was little doubt in my mind that I had a big job ahead of me. During my take-off accident in July 2019, I not only totalled my plane, I damaged the floats pretty badly too. Although I had obtained quotes on having them repaired by someone else, I thought it was in my own interest to do it myself. After all, I built them in the first place, so who would know their construction better than I do.

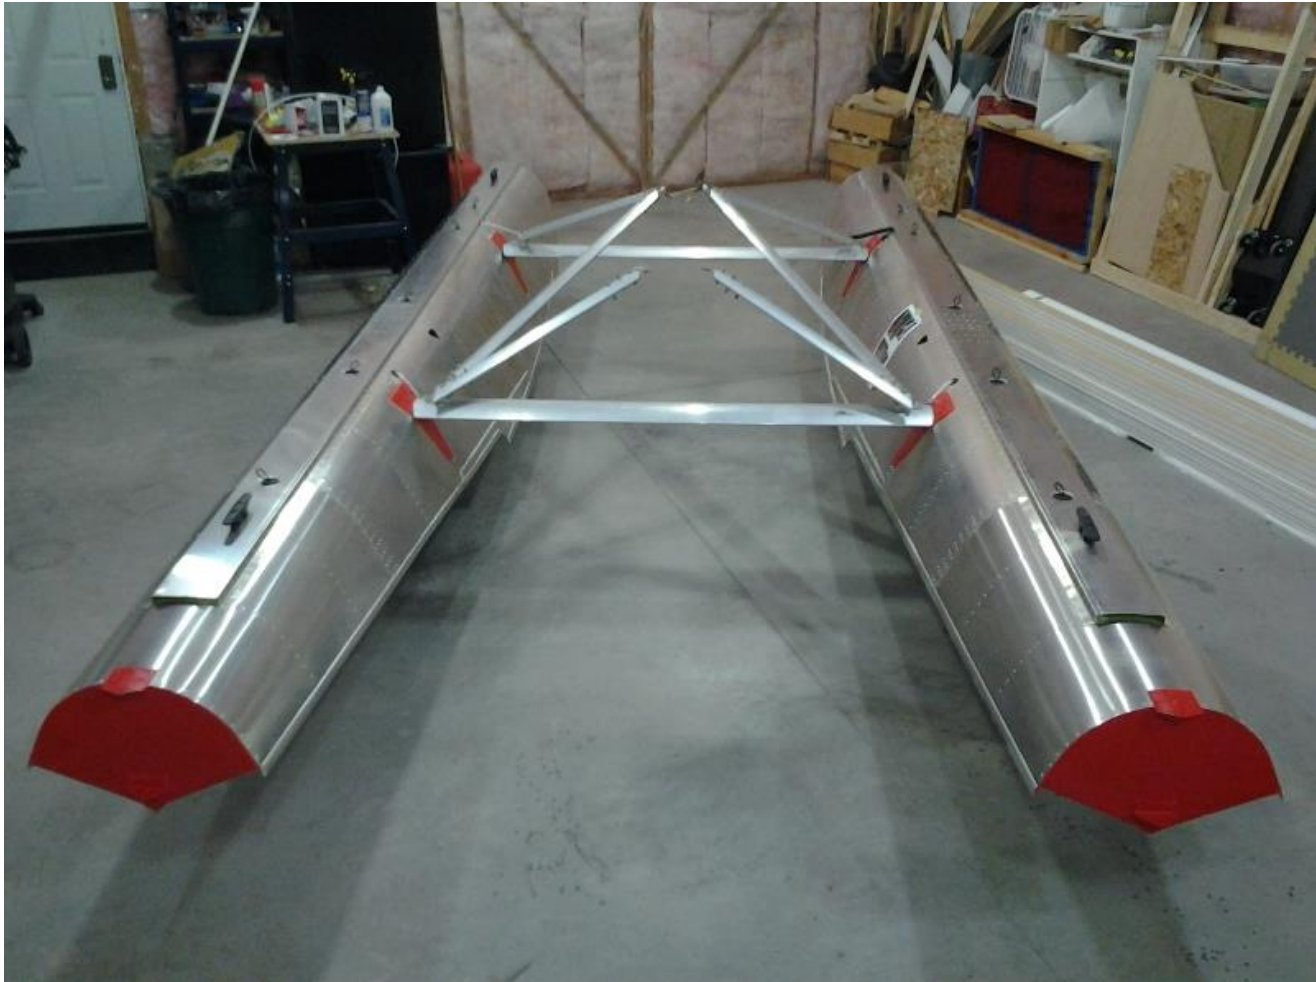
This is how my newly-completed floats (minus the rudders) looked in 2016. I am hoping to restore them to their former glory. Besides the shine in the floats, where did all the floor space go? Did my shop shrink over the years?

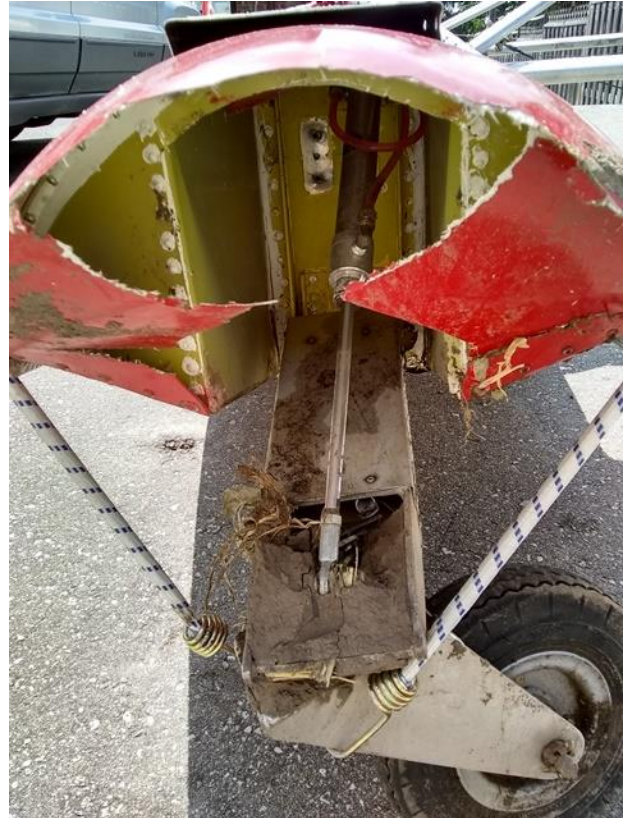
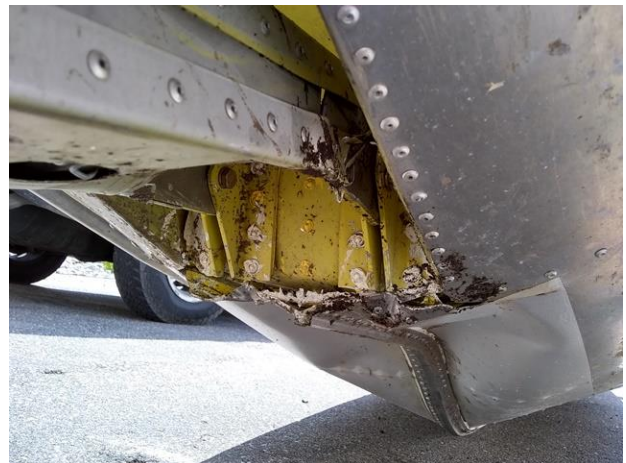
There was considerable damage to both front fork and swivel assemblies as well as the front of the lower skins and several of the bulkheads in the front were buckled. Luckily, most of the extrusions (mountings) were undamaged, merely loosened from rivets popping loose.

The nose cones were destroyed, but the hydraulics seemed to still be fully operational and none of the hydraulic cylinder shafts bent. The front keel was badly bent on both floats. The side skins only had minor dings and the walkway was undamaged. As I said at the beginning, there was little doubt in my mind that I had a big job ahead of me.

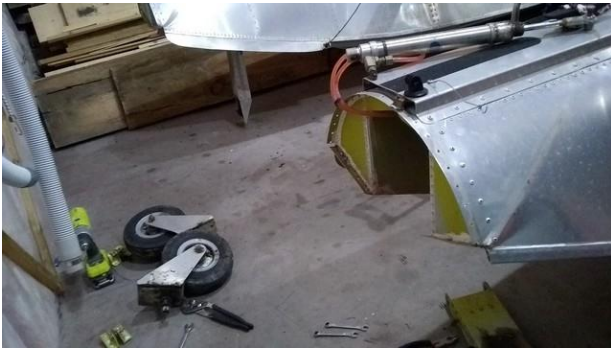
I started by removing anything that was bolted on and safely stored the parts in large bins.

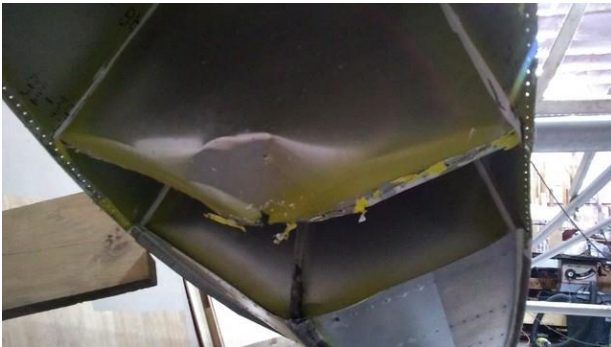
I then removed the front bottom skins as far back as the damage appeared to go. I cut the squeezed rivets off with a hammer and chisel after trying to drill them off to no avail. Shearing them off with a sharp chisel was not only faster, but did a much cleaner job of it. I had to hold the chisel just right so as not to cut into the aluminum skins as I carefully drove the chisel home with a hammer.

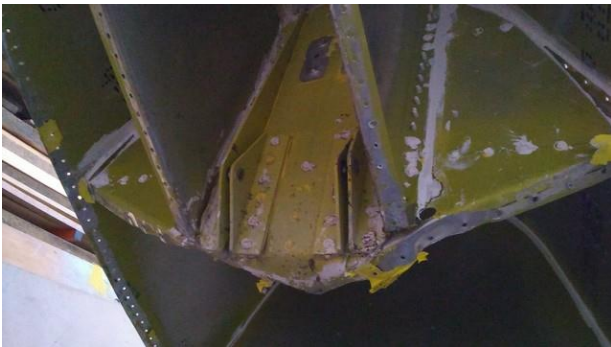
Once the lower skins were removed, the damage to the bulkheads was more apparent, but still what I expected to see.

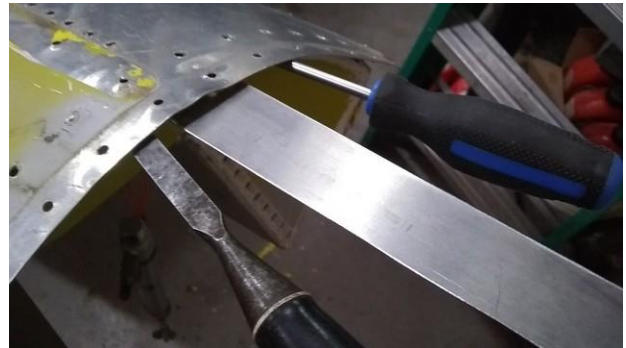
Drilling out the pulled rivets was the method of choice to gain access to the sealant that still held everything together. I made a small ruler-like tool with a sharpened end that I used to cut

the sealant along the rivet lines after removing the rivets. It was painstakingly slow work, but it did work!

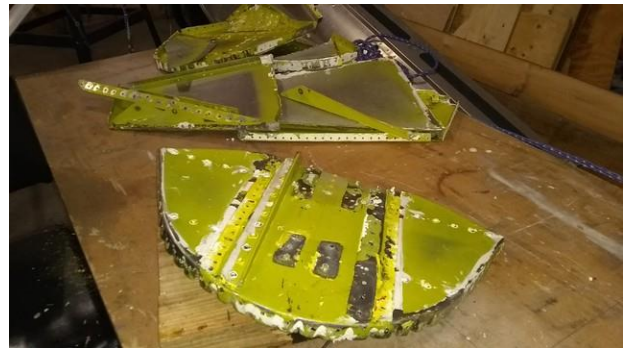
After removing the front wheel bulkhead assembly, I began drilling out all of the rivets holding all of the mounting brackets and reinforcing extrusions.

Many of the rivets inside are structural stainless steel rivets and presented quite the challenge to remove. I found that the bits of mandrel left inside some of them meant that I was replacing drill bits quite often and sometimes could not get the drill bit to align with the centre of the rivet.

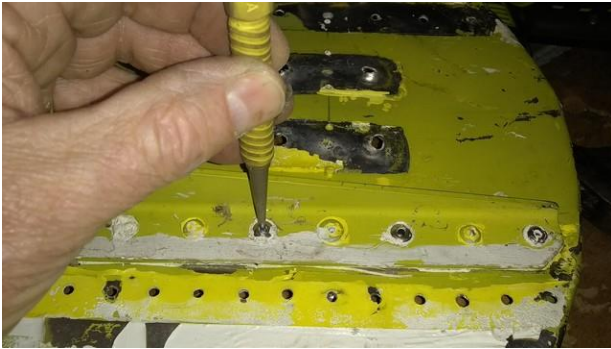
I found that driving the mandrel bit out with a small centre punch worked well and made the drilling job easier. Applying a drop of cutting oil to the tip of the drill bit made the job easier and faster as well as reducing my dulled-out drill bit to rivet ratio substantially.

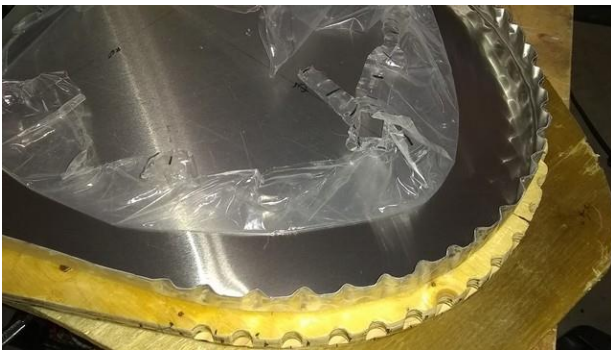
Although I could have purchased the replacement bulkheads from Zenair in Midland, I wanted to learn some of the basics of aluminum aircraft construction and decided to make my own bulkheads. Besides, if I wasn't happy with them, I would just order some from Zenair. So, I watched a few videos, made a wooden form and proceeded to pound out a few bulkheads.

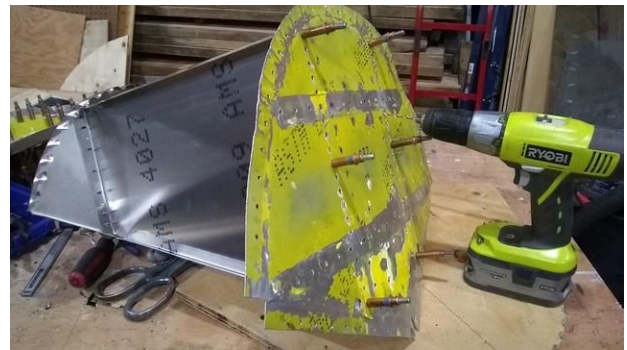
The flattened bulkhead served nicely to align all of the critical holes and then many of the final holes could be back-drilled through the extrusion to ensure perfect alignment on the new bulkheads.

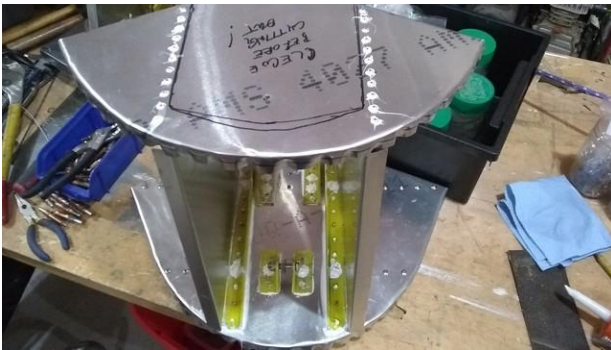
Once everything was cleaned up and the new aluminum roughed up a bit, I added the sealant to each joint and began final assembly.

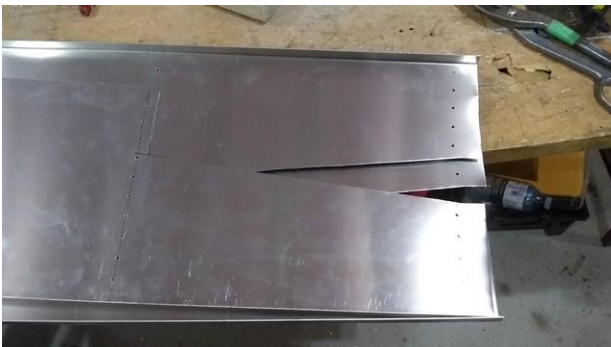
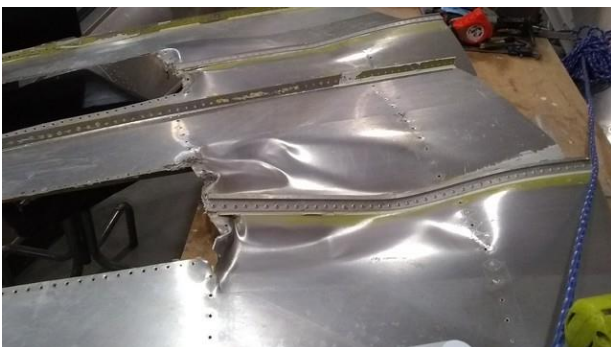
The new and original skins are shown here for comparison. I only replaced the bent section, but did a triple row of rivets and overlapped the bottom skins at a bulkhead to ensure a very tight and secure seal.

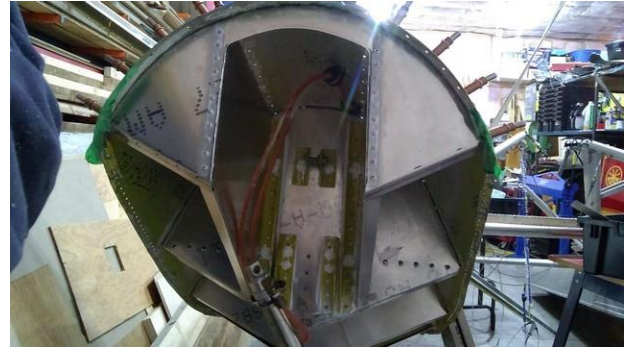
I trial fit the wheel bulkhead assemblies into the floats,

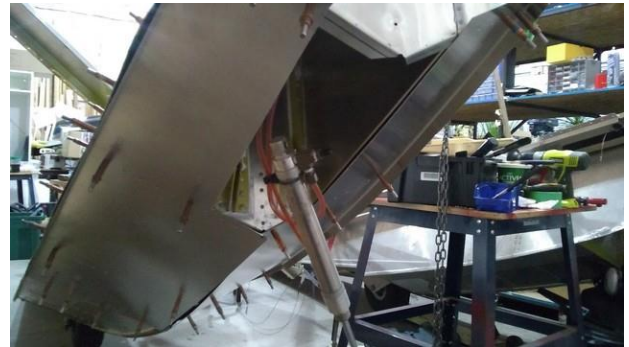
then trial fit the new bottom skins.

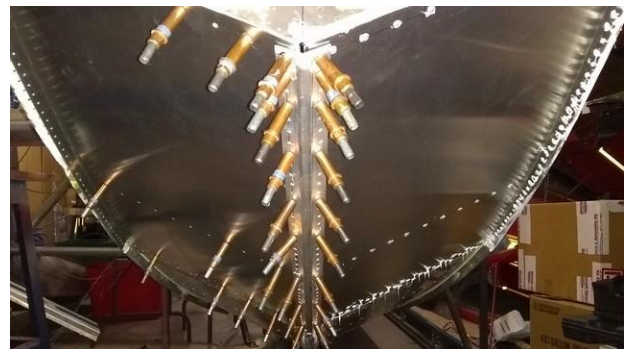
I then test fit new pieces of keel extrusion and drilled half a bazillion holes to mount them temporarily with clecos. Next, I drilled another half a bazillion holes out the bottom skins to match the holes that take 3/32" squeezed rivets that join the bottom skins to the side skins. I then disassembled everything and deburred all one bazillion holes.

Once I was satisfied with the fit, I cleaned and roughed up the surfaces and began sealing

things up with Sikoflex sealant as I riveted things in place.

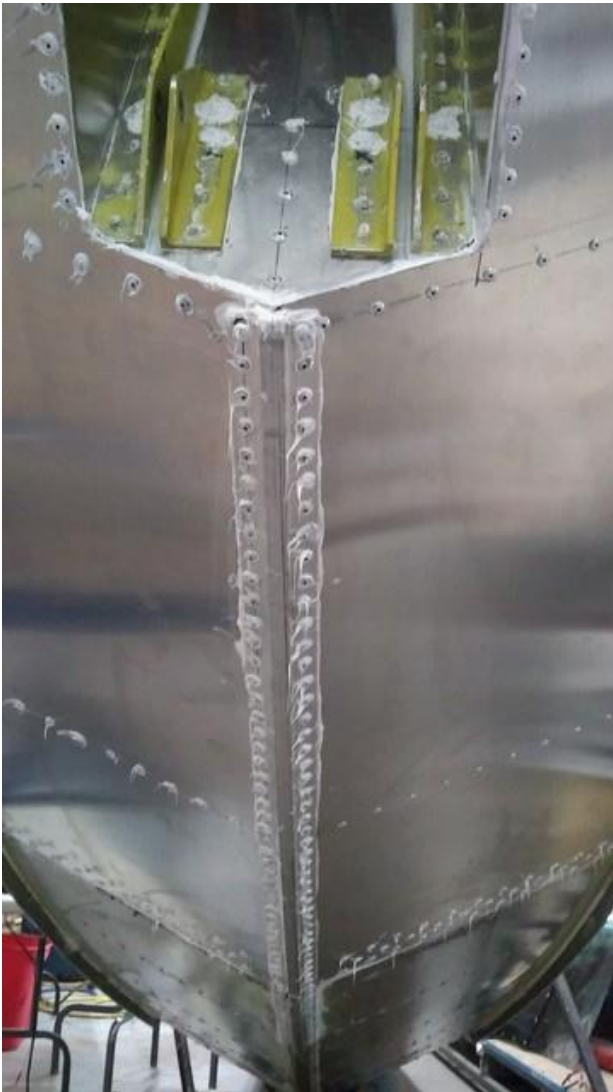
Over the next several days when I had a few spare moments, I would rub each of the rivet heads with a piece of crepe block to rub away the excess sealant. It's slow work and cramps the hand up, so I did it piecemeal rather than attempt it all at once.

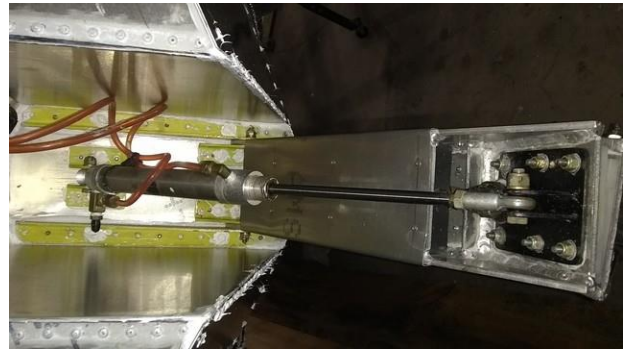
Once together, I retested the hydraulics, bled out a little air and refilled the reservoir. I tidied up the hose lays under the walkways and remounted the walkways with rivets and sealant. It is worth noting that I dipped every pulled rivet in sealant before inserting it into the holes to ensure a nice tight seal as well as a secure fitment when squeezed. This meant a little extra cleanup of excess sealant was required, but I don't want to spend a lot of time chasing leaks in the floats.

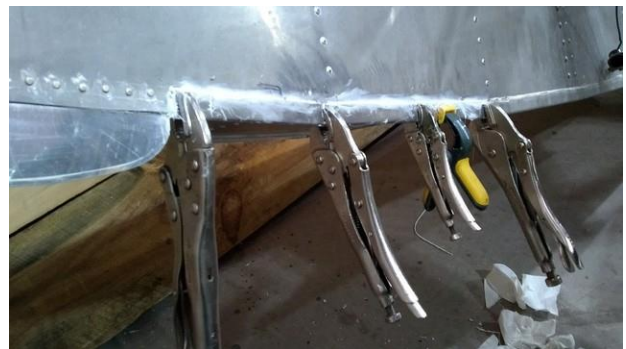
As I finished the final assembly, I noticed that the EDO-style pump-out cups were very rough with crud that had built up on them and the rubber plugs were also rough with crud. The original plans on the Zenair floats only had flimsy plastic caps that fit into holes to be drilled in the side of the floats near the walkways. When I built them in 2015/2016, I ordered and installed the EDO-style pump-outs to make the floats look a little more refined and make the pumping-out process easier. There's nothing wrong with the standard Zenair method, I just like the EDO-style cups and plugs better.

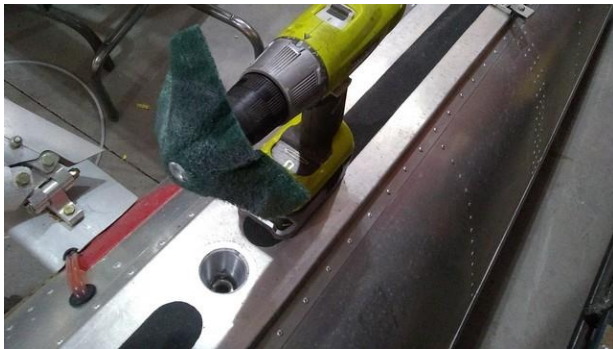
I mounted a Scotchbrite pad on a drill mandrel and used that to clean and polish the inside of the cups and then used a flat piece of Scotchbrite and some cleaner/de-greaser to clean the rubber plugs. I was very pleased with the resulting smooth and clean surfaces, which should restore the seals to like-new condition.

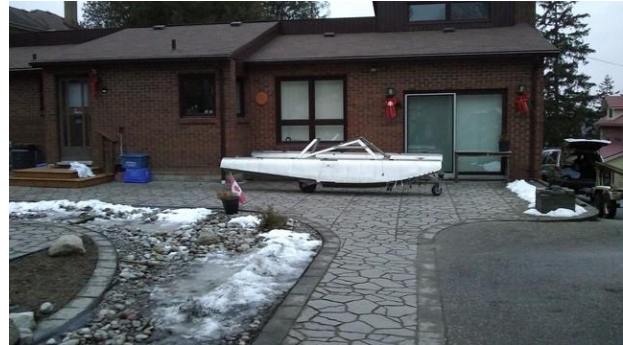
With winter closing in fast and 2021 coming to an end, I wanted to get Aerial 2 inside for the winter. As you likely know, I do not have a hangar at an airport currently, and as such the floats have been moved back onto the patio that has served as their home for the last two years. I see this as a temporary home and expect to mount the plane on them as soon as possible, likely sometime in May.
