- March 2022 -

Horizontal Stabilizer Inspection and Repair

(Fatigue-related Failure of Aluminum Parts)

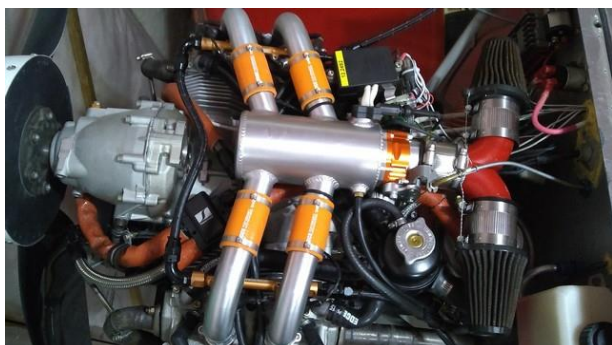
For several years now, Edge Performance in Norway has been producing some well-engineered modifications for the Rotax 912 series of engines. When I began construction of Aerial 2, I wanted to increase reliability, improve fuel economy, and reduce weight, while increasing power and torque as much as possible on my Rotax 912ULS. EP's EFI fit my requirements nicely.

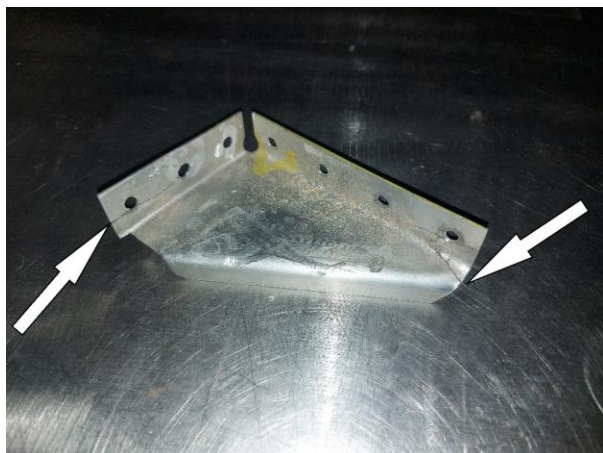
I was alerted to cracks in the centre hinge gusset by another RAA member who found similar cracks in his. The gusset supports the hinge laterally. Complete failure of the gusset would not be catastrophic, but it would subject the hinge to greater stress and premature failure.

I kept a very close eye on this part before I repaired it, but the extent of the cracks was not visible until the elevator was removed. Lesson learned. Pay extra attention to this part at the walkaround and replace it at the first sign of cracks. It is not easy to see this part, so a casual look is not sufficient.

Cracks in elevator hinge gusset

One final piece of the puzzle is the question of what caused the cyclic stress that led to the failure of these parts and is it possible to reduce or eliminate it. I showed a picture of the hinge gusset on an internet forum and several "experts" insisted the elevator is binding and flexing the hinge. This is not the case, but if it was, it is certainly something that should be corrected promptly.

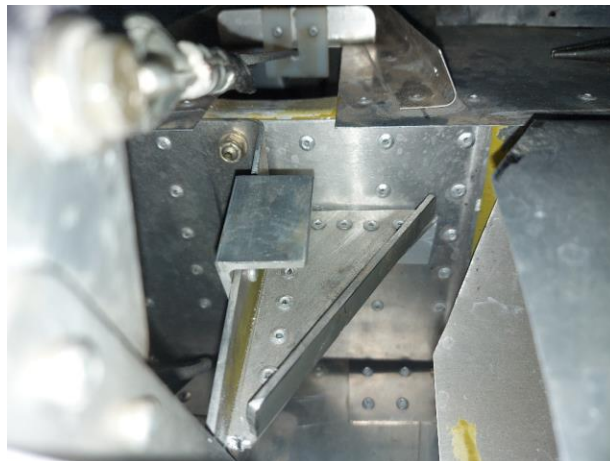
I fabricated a new gusset from extruded aluminum angle and thicker aluminum sheet. This gusset has held up well. It is important to note that since it is stiffer, the gusset will transmit more stress to the elevator hinge. Failure of the hinge would likely be more serious than failure of the gusset, so I am very strict with my walkarounds and inspections of these components. The most likely failure points on the hinge would be near the end where the gusset ends or at the hole where the elevator pivots. These points are visible on both sides of the hinge, so inspection is not difficult.

New gusset installed on elevator hinge

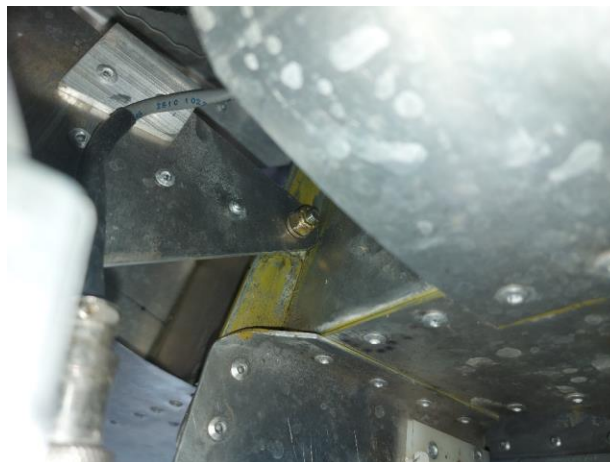
Opposite side of elevator hinge
(This part is easily observable during a walkaround.)

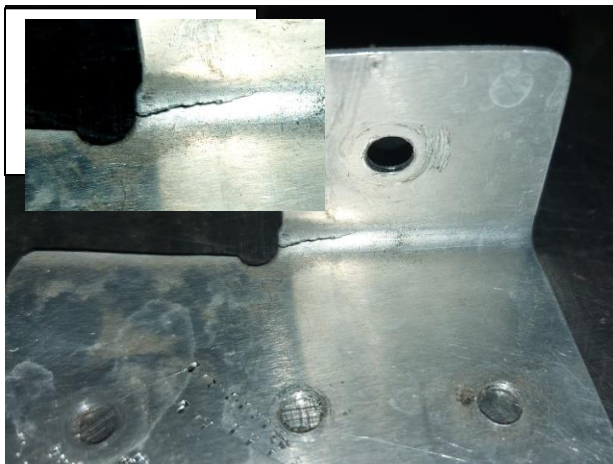
At my annual inspection this year, I found cracks developing at both rear gussets. This time, when trimming the gussets to fit, I used a larger diameter drill to provide a greater stress relief at the corner where material was removed. I also polished, instead of sanding the surface.

Old gusset showing a fatigue crack

Notice that the cracks started at a stress concentration point and that there is no permanent deformation of the parts. They are fatigue cracks making their way through the material and would have eventually led to a complete failure of the parts.

The horizontal stabilizer is attached with four brackets. Each bracket has a gusset made from formed 0.040" aluminum sheet. The gussets must be trimmed to fit, and it can be difficult to trim just the right amount of material to fit, while maintaining the required hole edge distances. In fact, I trimmed too much material from one when we were initially building the airplane. I scrapped that part and made one from some thicker material I had on hand. This thicker part cracked at the bend several years ago and was replaced with a new part from Zenair.

Another lesson reinforced. While aluminum is reasonably ductile, thicker sheets require greater bend radii. Forming the part with thicker material and the same bend radius work hardened the material and made it brittle, which quickly led to a crack.

It remains to be seen if the new parts will last longer, but they are not too difficult to replace, if necessary. Again, these are gussets, so a failure would not be catastrophic, but could lead to serious consequences if ignored. In this case, I did not attempt to re-engineer the parts because I had factory original spares on hand and the original parts lasted seven years.
