Monthly Newsletter of the Kitchener-Waterloo RAA

- April 2019 -

ELTs, ADS-B and Position Tracking Update after TSB Investigation Report A17P0170

Aviation Investigation Report A17P0170

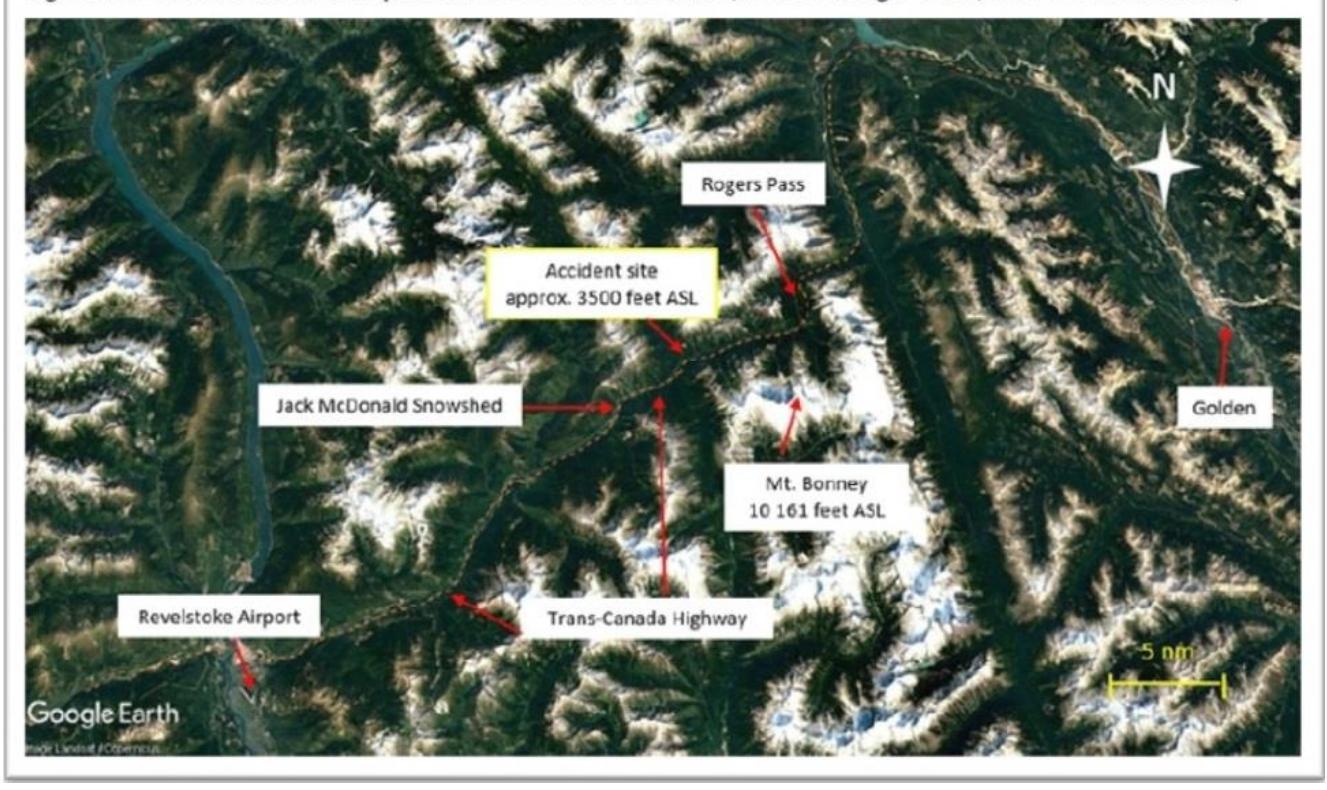
Figure 1. Aircraft's last known position and the accident site (Source: Google Earth, with TSB annotations)

The TSB report for the Mooney that was lost between Revelstoke and Golden, B.C. during November 2017 highlighted yet another failure of an ELT. We all knew at the time that the ELT didn't function and that telephone CEL towers were receiving something, but not enough to be found. It took 9 months for a passing helicopter to see the crumpled wreckage. The irony was that the aircraft impacted just 150 m away from the TransCanada Highway near the Rogers Pass.

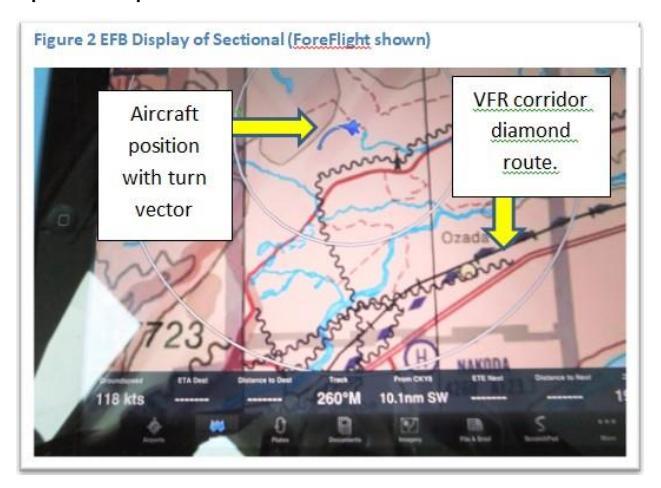
screaming through the area at 131 kts, with speeds up to 147 kts.

The EFB in the mountains also helps to identify the right mountain pass. Often a slow-down is necessary and an orbit is helpful to keep on the right track.

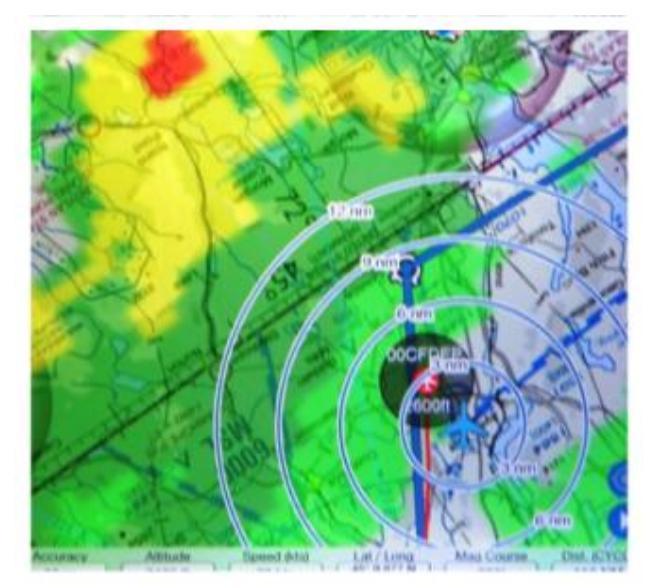
Fig. 3. ADS-B weather screenshot for illustration only

The ADS-B weather in aircraft has proven very useful in avoiding weather when I travel near the border. Weather is loaded from the ground stations and retained in the display memory. If this service were available, the latest METAR, TAF and regional WX radar could be available from the Revelstoke RCO. The weather radar could have been useful in alerting the pilot of what was ahead. This radar is located 80 nm to the southwest near Silver Star Mountain at 6200 feet ASL. WX radar in the mountains is deceiving as there is almost always a lot of stationary clutter. A call to Flight Service could provide clarity.

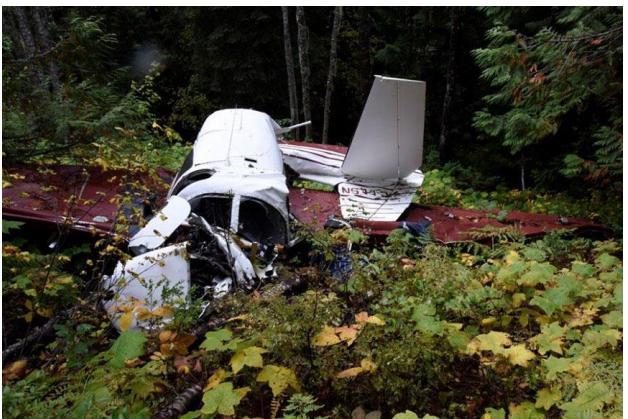
Fig. 4. Remains of the Mooney when finally found

The TSB reported... "The aircraft's 121.5 MHz ELT was also recovered at the accident site. The ELT's antenna was found detached from the connector, and the batteries had been ejected from the battery enclosure during the impact sequence. When initial power was applied to the ELT, it started to transmit a strong signal, which confirmed that the inertia switch was in the activated state."

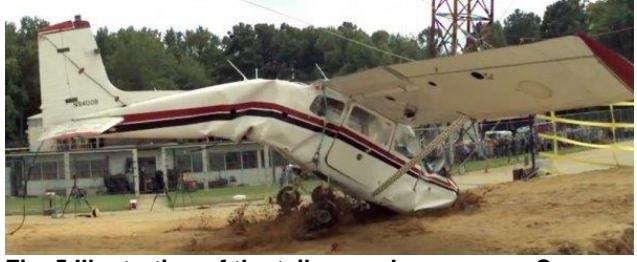
Fig. 5 Illustration of the tail crumple zone on a Cessna

When NASA did crash worthiness tests, this airframe location turned out to be a structural weak point, causing the ELT and antenna to be

caught in the middle. The FAA and Transport Canada provide little guidance in locating ELT components, so the TSB Recommendation A16-05 needs attention. More needs to be addressed than just the removal of hook and loop fasteners highlighted by Transport Canada in ASL Issue 1/2017.

ELTs have been in use in Canada since the 1970s. The 121.5/243 ELT to TSO C91 have evolved over that time with better batteries and packaging but the basic trouble is that they were a compromise from the original concept of an ejectable Crash Position Indicator (CPI). The FAA forced the ELT regulation as key accident cases in Alaska drove the introduction into "new" aircraft in the 1970s. At first they were installed at the rear of the aircraft, very close to the tail empennage, considered the most survivable part of the airframe. As time went on, people moved them to more convenient locations in the rear of the cabin. A great number of high wing Cessna models now have the ELT and antenna behind the rear window.
