Monthly Newsletter of the Kitchener-Waterloo RAA

- November 2021 -

Fuel Contamination of Searey C-GJIB

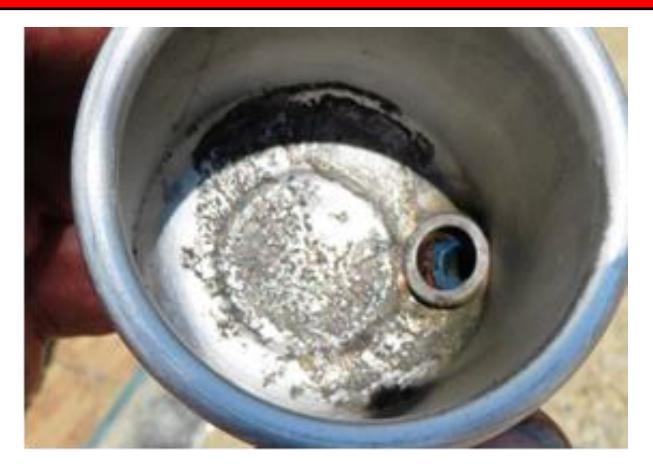
The annual inspection items were started and revealed some serious warning signs. First, black crusty corrosion was found at the bottom of the gascolator bowl. This is the lowest point in the fuel system but cleaning still left some pitting in the aluminum bowl.

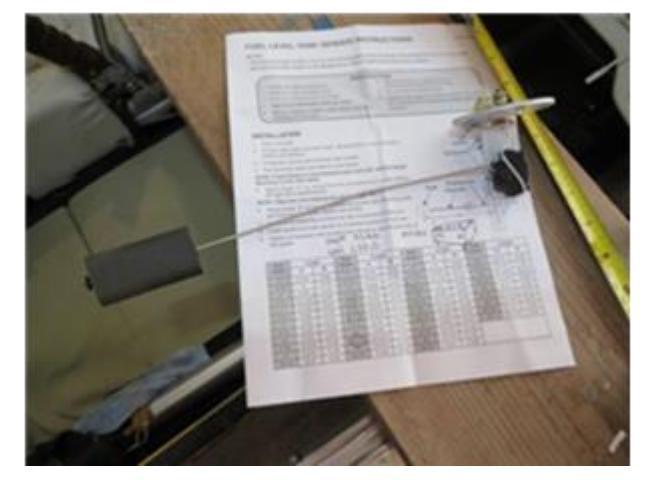
The next item was the fuel sender. All my engine gauges were compromised by the water, so I had replaced the six electrical meters with an MGL Engine Management System (EMS) and its associated remote sender (RDAC).

The full tank level indicator showed full scale but a little bit of troubleshooting resulted in the conclusion that the fuel tank sender was open circuit. I did not realize how susceptible these fine wire sensors are to water corrosion. I replaced it with an automotive universal long arm sensor and did an initial calibration. The conclusion is, don't use these sensors in any water.

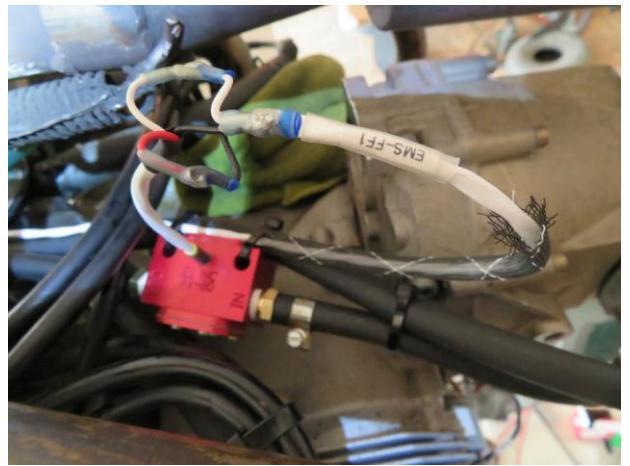
This is when I noticed more of the black crud showing up and decided to put in a fuel flow sensor. Why not; the EMS had a connection for a fuel flow input and I could detect any flow reductions, right? I quickly found out that fuel flow sensors are not cheap. Mine was \$268, and I was warned that sometimes they could actually clog up and restrict fuel flow. Furthermore, there are strict mounting requirements to avoid bubbles and debris. Anyway, the ability to monitor fuel flows and verify fuel consumed/remaining was just too intriguing. Besides, the manufacturer assures us that the sensor will not restrict fuel flow, if installed properly. I mounted the sensor on top of engine to avoid turbulence from the pumps and wired it back to my EMS sensor unit (RADC).

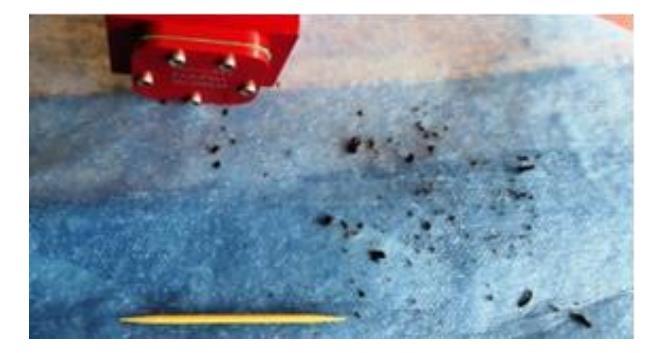
I took the sensor off the airplane, ready to send it back for repair. Upon a closer look, the ugly truth was revealed. There were a lot of familiar little black bits in the sensor impeller.

It took a few tries to get it all out. So where was all this crap coming from? The input to the mechanical fuel pump seemed to be clear but the line out of the pump looked like chopped liver. I presume that some tubing bits got chewed up in this pump. Luckily, not much of this made it to the carburetors. After replacing the line, from here on in it would require vigilant monitoring of the bowls and the gascolator to get ready for flight.

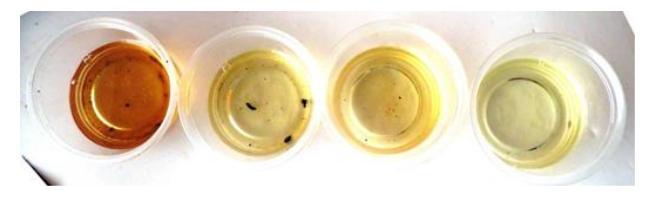
As you can see from the samples shown above, there is severe discolouration for the older fuels on the left, and yes there is some contamination. The most dramatic change occurred when I switched to Shell 91. Not only was it "fresh" but it had no ethanol added.
